Around the house with DoubleCheck Inspections Inc. Sidings

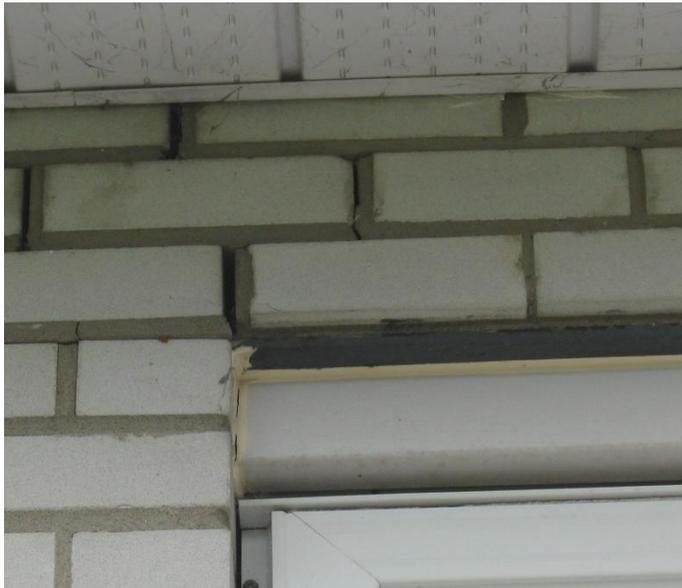
The home inspector found this crack above the door. This crack is about two times larger above the door than the one found in the foundation at the door sill.

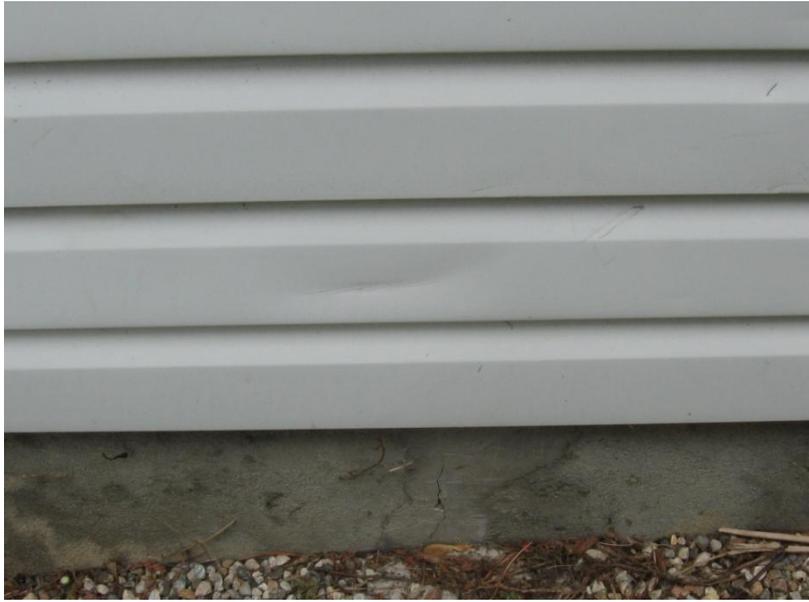
The home inspector found this dented or damaged aluminum siding.

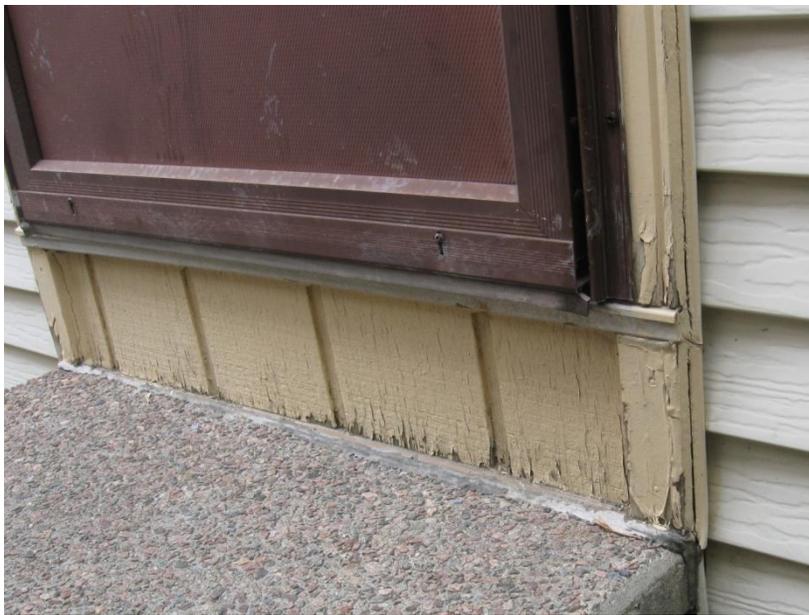
The registered home inspector found this rotted wood below the door.

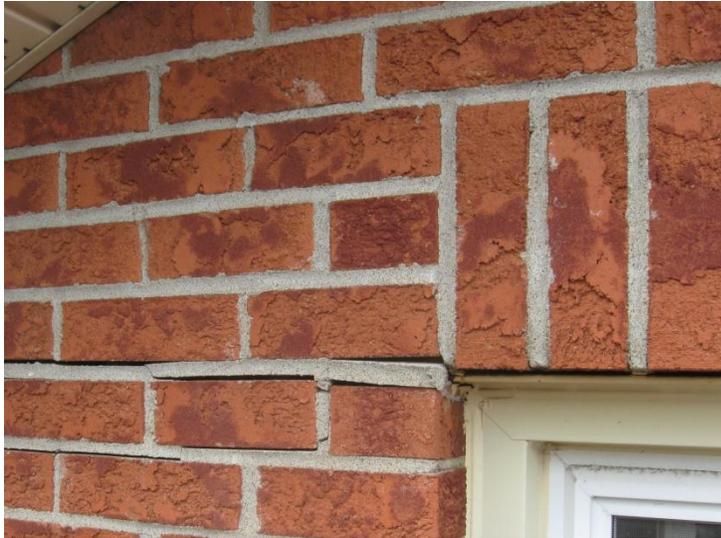
The home inspector was able to get onto the garage and found this serious crack in the brick. We called for a structural engineer to perform a thorough full review of the foundation.

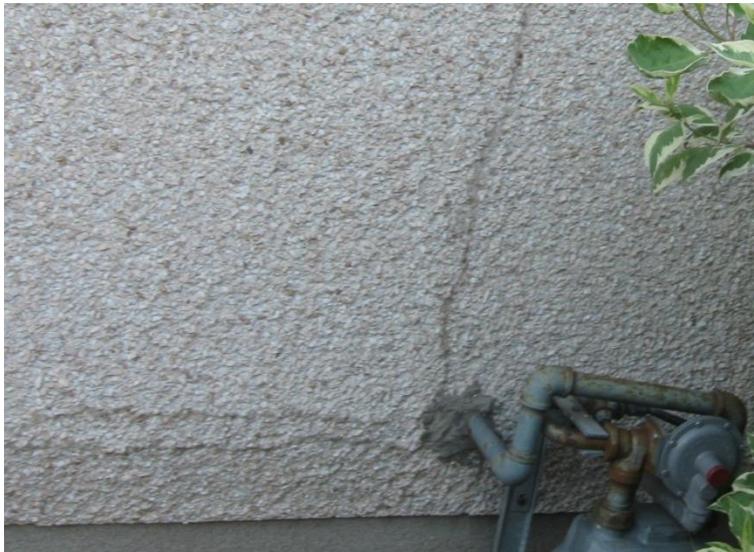
At ground level the home inspector found the stucco sagging, which is common on this dated material.
